| 番号 12 | | 調査記録表 | | | | | | | | | | 管 理 機 関 | | 岐阜県可児郡御嵩町 | | | | | |
| 路線名 | | 2-1 水口・東山線 | | 整理番号 | | 切土18 | | 施設管理番号 | | 所在地 | | 御嵩町大久後地内 | | 距離標(自) | | 0.1 70 (至) | | 0.2 0 | |
| 施設種別 | | 切土のり面 | | 施設種別詳細 | | 自然のり面 | | 施設延長(m) | | 30.0 | | 完成年月 | | 不明 | | 最新の補修履歴 | | 不明 | |

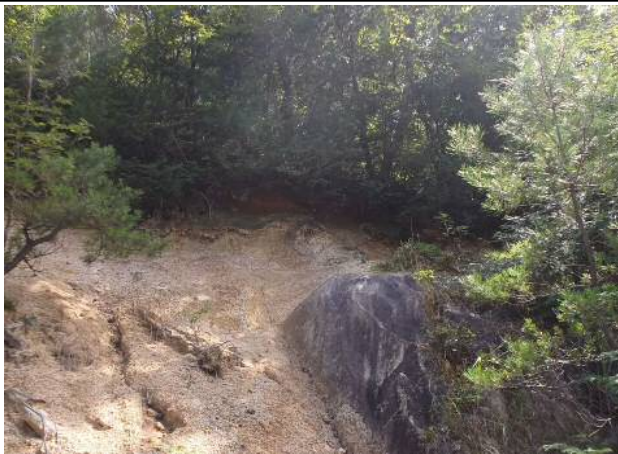
| <p><一次調査結果> 調査実施年月: 2014 年 7 月 所 見: ・切土のり面表土の洗掘が認められる。(写真③、④) ・表土の洗掘により、のり面上部においてオーバーハング状態となっており、今後の進行状況によっては前面道路に土砂の崩落が懸念される。(写真⑤、⑥) ・土砂の流出により、切土のり面前面の排水側溝内に土砂の堆積が認められ、排水障害が発生している。(写真⑦、⑧)</p> | | | | | | | | | | <p><二次調査結果> 調査実施年月: 2014 年 9 月 所 見: ・一次点検で確認した事項に加え、のり面上部の立木根本部分がオーバーハング状態となっており、降雨や風等で立木の倒壊も懸念される。(写真⑤、⑥)</p> | | | | | | | | | |

③土砂の洗掘

| 今後の対応: 1. 表土の洗掘を防止する対策(のり面吹付け等)を検討する必要がある。 2. 切土のり面前面の排水側溝内に堆積した土砂を除去し、排水経路を確保する必要がある。 | | | | | | | | | | | | | | | | | | | |

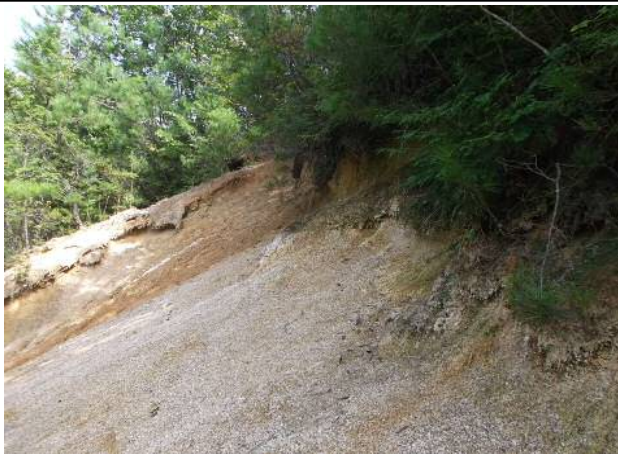
④土砂の洗掘
